Home Integrity Inspections

Confidential Inspection Report

1801 Condo St #211

Inspection Date: January 14, 2014 - 8:00 AM.
 Client: Your Name.
 Inspection Site: 1801 Condo St #211
 San Diego, CA 92110.
 Occupied? Yes.
 People Present: Occupant, Purchaser, Inspector.

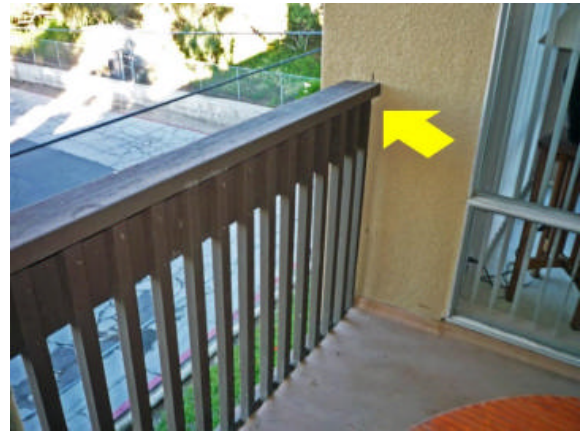
Rear Patio / Porch: Acceptable However; the Railing is a bit loose at the wall.

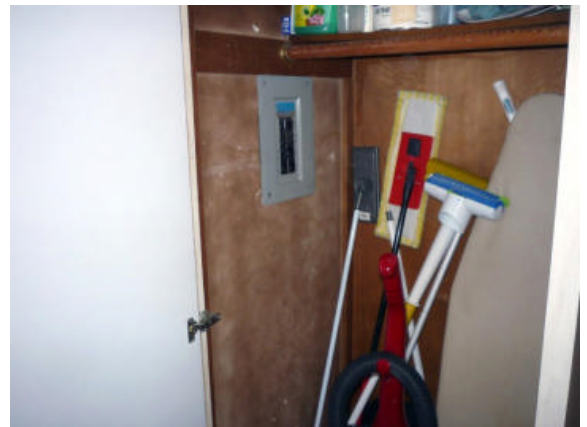
Circuit breakers are without the benefit of clear and complete labeling.

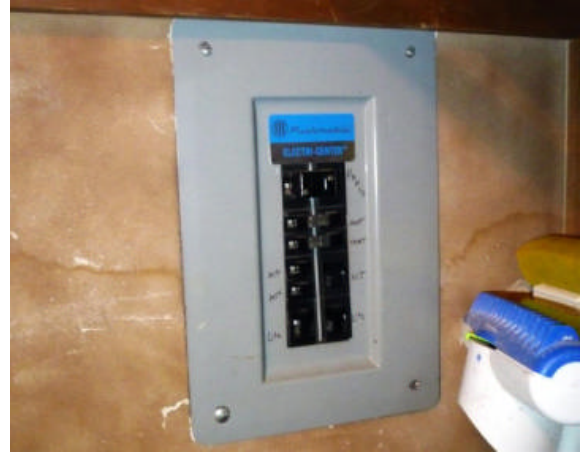
Incorrect Screws are used for the panel cover. One of the screws is missing. Replace as needed.

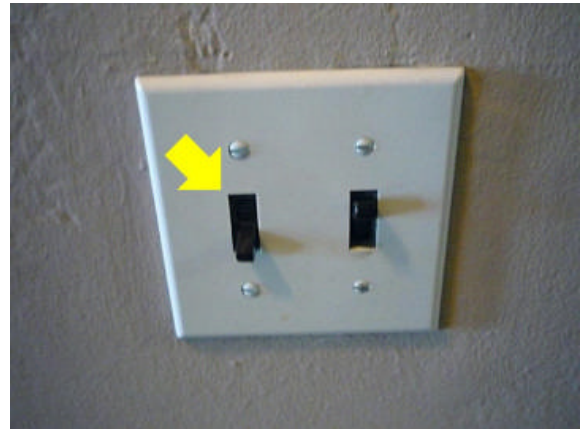
Entry Area: One of the Switches is for an outlet in the Living Room. However; there is constant power at the outlet. Wiring needs to be evaluated by an electrician.

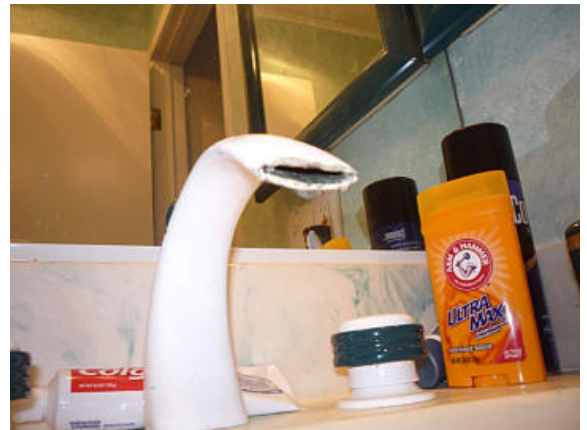
Master Bath: Operable. However; Some repairs or replacement is needed. Mineral deposits observed at faucet should be cleaned/removed if possible in order to prevent further deterioration.

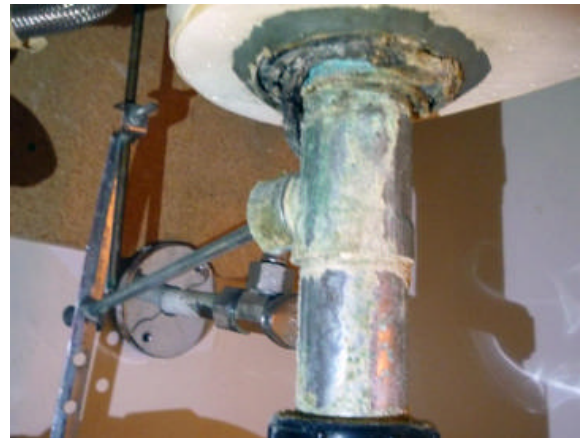
Corrosion was observed at the drain pipe and its connection to the sink.

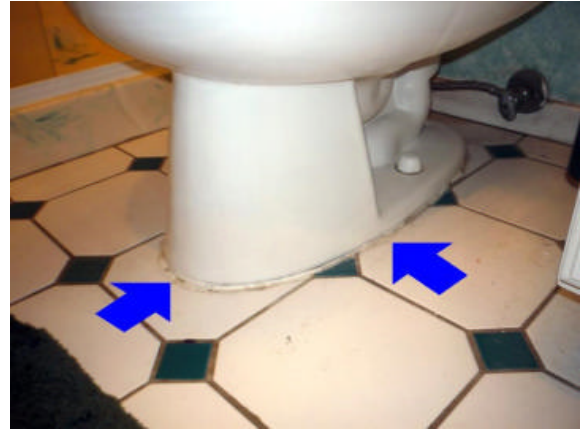
Acceptable
Maintenance Issue, Caulking
replacement is needed at toilet
base to floor.

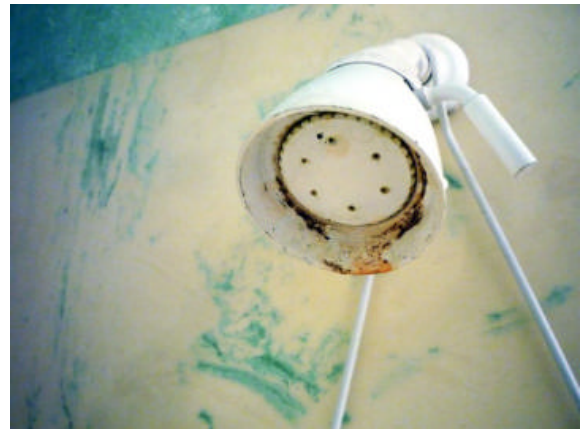
Operable. However;
Corrosion/Damage noted at the
Shower Head.
Recommend caulking around
fixtures to prevent water intrusion.

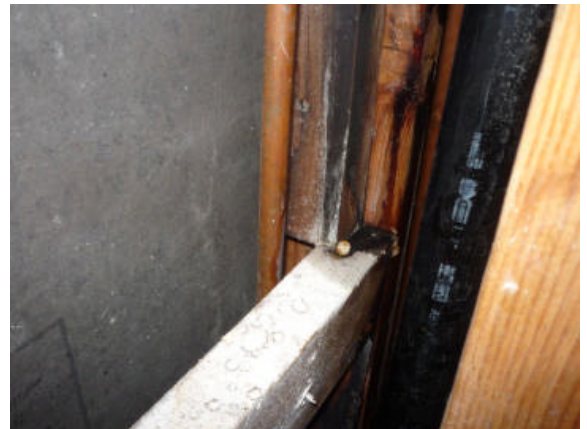
An active plumbing leak was
observed inside the wall cavity
behind the Shower Fixtures.. Water
dripping down inside the wall may
cause damages to the unit below.
Repair is needed as soon as
possible.

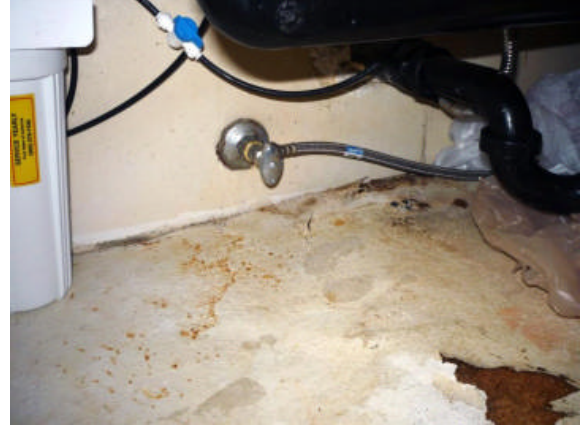
Wood Cabinets with Composite Tops. Acceptable with the exception of damaged wood materials located below the sink. Evidence of past leakage was observed. It does not appear to be an active leak at this time. However; there may be the presence of microbial growth in the wall, flooring or adjacent cabinet materials. Recommend having an expert remove and repair the damaged wood and also to further inspect for any hidden microbial growth.

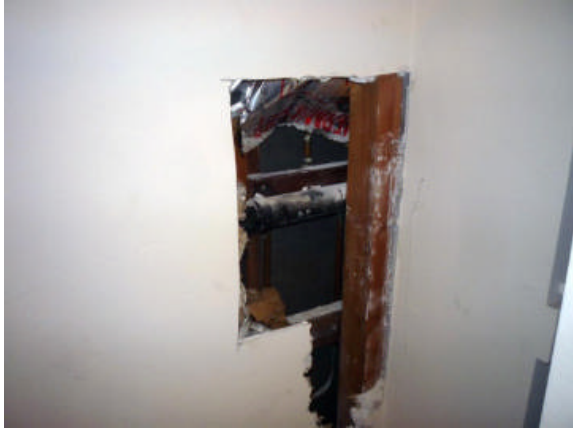
Master Bath: Acceptable.
 Bath 2: Acceptable.
 Entry Area: Acceptable.
 Living Room: Acceptable.
 Den: Acceptable.
 Kitchen: Acceptable.
 Master Bedroom: Acceptable Overall. However;
 Drywall repair is needed inside the
 Closet.

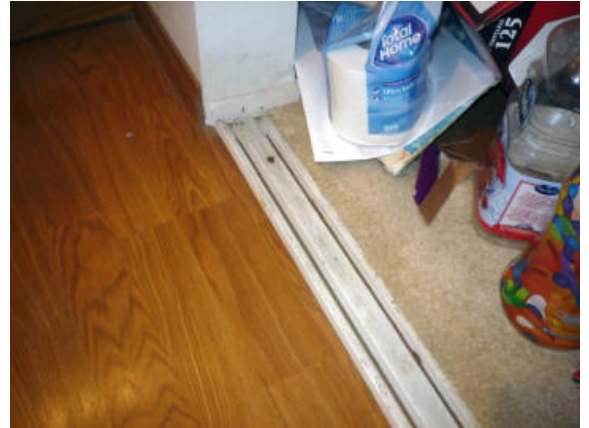
Den: Acceptable Overall. However; the closet door bottom track was installed out of level and needs repair in order to function as intended.

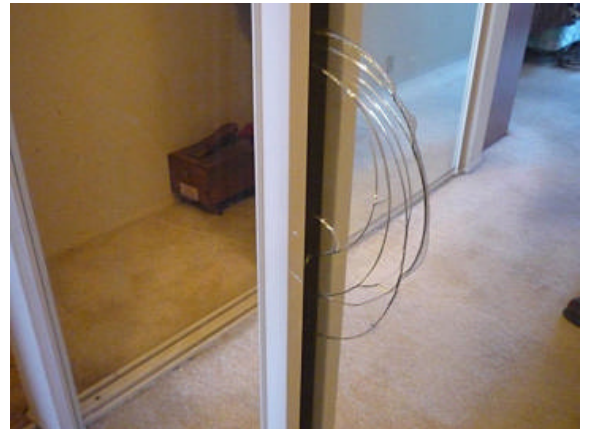
Master Bedroom: Acceptable Overall. However; One of the Mirrors is damaged at the Closet Doors .
